Pulley Alignment Tension

Today's belt performs a specific job: transferring power from the crank pulley to all accessories in the Automatic Belt Drive System (ABDS). On average, a Micro-V® belt has to cycle over 350 million crank shaft revolutions in 100,000 miles which translates to nearly one hundred million belt revolutions depending on the length of the belt. Power-hungry alternators, air conditioners, power steering and water pumps all try to rob the belt and keep it from transferring this power. To say the least, it's no small task to keep all these parts functioning properly, especially under extreme temperatures.

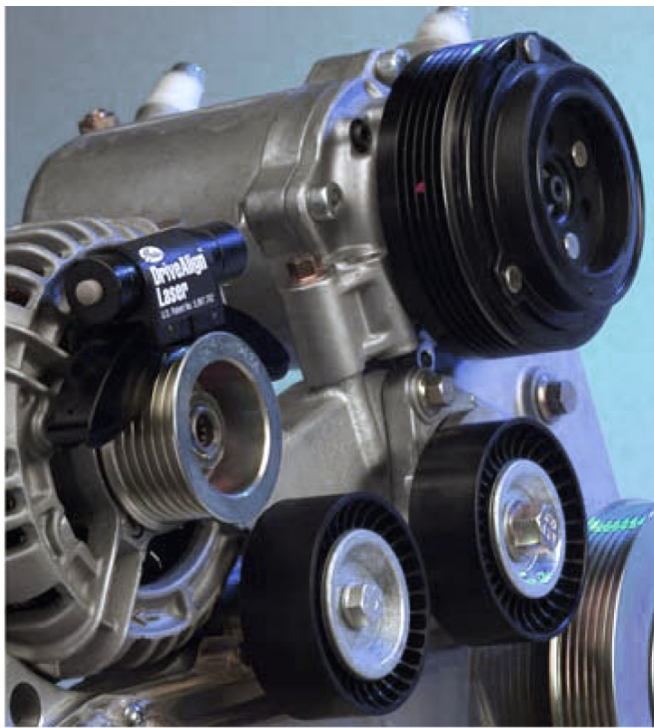
Use Gates DriveAlign® Laser Alignment Tool (Part #91006) to quickly identify pulley misalignment.
